Barn Structure

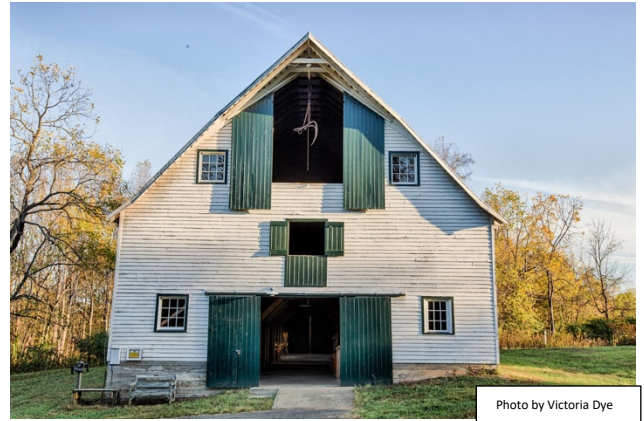
Many features of the building emphasize the Extension Service's focus on cleanliness. The building is whitewashed. It has a concrete floor which could be washed down, unlike the dirt floors in most barns. The trench by the milking station collected the cows' waste. This would have been shoveled out and the valuable manure used on the farm for fertilizer. The wide, flat-ended shovel hanging on the wall exactly fits into the trench for this purpose.

There is a durable tin roof and ventilating cupolas. The profusion of glass windows allowed light to fill the barn.

The barn had sliding doors to separate the area housing the horses from the milking area in accordance with best sanitary practices. The metal stanchions held the cows in place while they were milked.

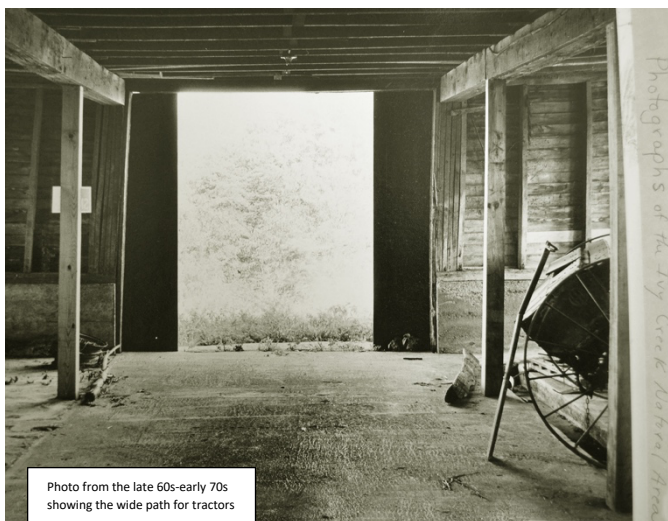
The granary was lined with galvanized steel to prevent rodents from eating the grain. The door to the guides' closet was once one of the granary doors. The granary was originally divided in two sections and this division may be seen on its ceiling.

Originally the barn had no stairs. Entry to the loft was up the boards nailed to the walls beneath the hay chutes.

The central aisle of the barn is wide so wagons could drive through it.

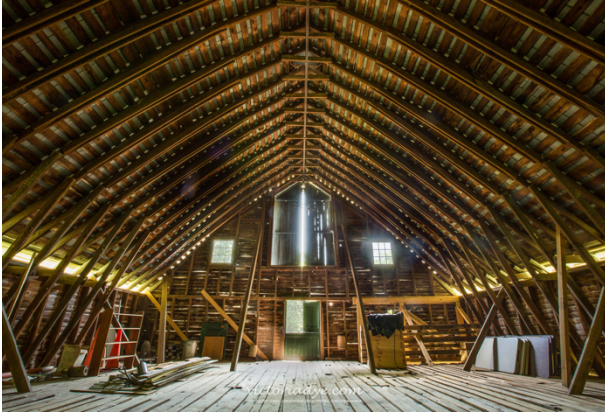
The immense, vaulted loft was used to store hay. The metal track that runs along the length of the loft forms the backbone of the innovative hay-transport system that got the hay up and into the second story of the barn. First, a horse would pull on a rope to hoist a loaded “iron claw” hayfork. Pulleys amplified the pull of the horses and lifted the hay. (The hayfork can be seen on the roof ridge by the visitor stairs. The pulleys are now on display as part of the collection of

tools in the stanchion area.) When the barn was first in use, the hay would have been loose. It may have been baled into square bales in later times. The hayfork could have held four bales of hay at a time. A trolley on the overhead metal track took the loaded fork the length of the loft. One farm hand in the loft of the barn would call down when the hay was in the right position to be released, and the farmer below would pull on a trip rope to release the load. Once the hay was deposited, a frame of boards kept the hay from the sides of the barn. This allowed the air to circulate and to prevent fires.

When the stored hay was needed for the animals, it was pitched down the hay “holes” or “chutes” to the troughs below in the barn. These hay chutes can be seen on the sides of the barn about half-way down the length.

There are thin strips of wood hammered over the places that the wide floor boards in the loft meet. These strips covered the gaps and kept chaff and dust from falling into the barn area below. The area of the loft over the granary does not have these strips of wood because the metal ceiling of the granary is impermeable.
